Project No. 1-LA105.15
Lab Ref No. 003/15
Page 1 of 3

LOAD TESTING OF SERVICE BOX AND LID

400mmØ Service box and lid. Installed in situ in soil at 98 Cryers Road.

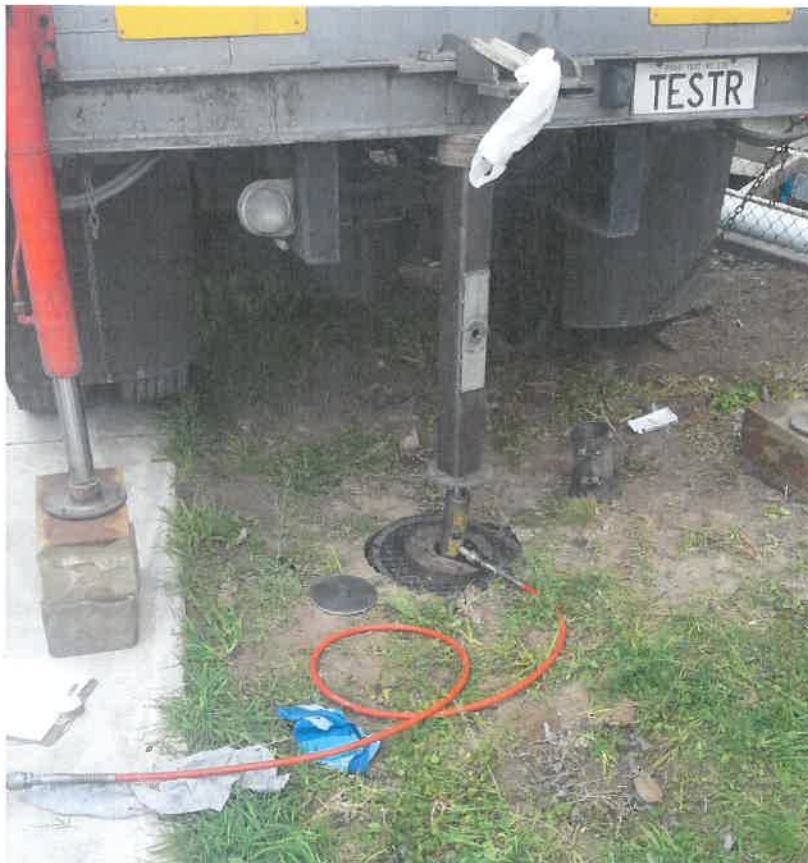
While attempting to reach 53.0kN, there was failure in the base at 26.9kN applied load– The lid being pushed down created a bulging effect in the base where the inside of the service box was buckling.

Figure 1 - Test set up. Photo shows load of 26.9kN applied hence the deformation in the service box.

The jack was set up underneath the back of a truck which was hydraulically jacked up off the suspension, using the truck hydraulic rams to give the jack something solid to push against.

Refer to figure 1 on page 3 for test set up photo.
